Inspection Report

Permit Number:	C0150032
Inspection Type:	PARTIAL
Inspection Date:	Thursday, March 10, 2011
Start Date/Time:	3/10/2011 10:00:00 AM
End Date/Time:	3/10/2011 1:00:00 PM
Last Inspection:	Wednesday, February 23, 2011

Site: **CRANDALL CANYON MINE**

On March 10th, 2010, Division staff members Steve Christensen and Kevin Lundmark conducted a field inspection of the Crandall Canyon Mine facility. The primary focus of the inspection was the mine-water treatment system.

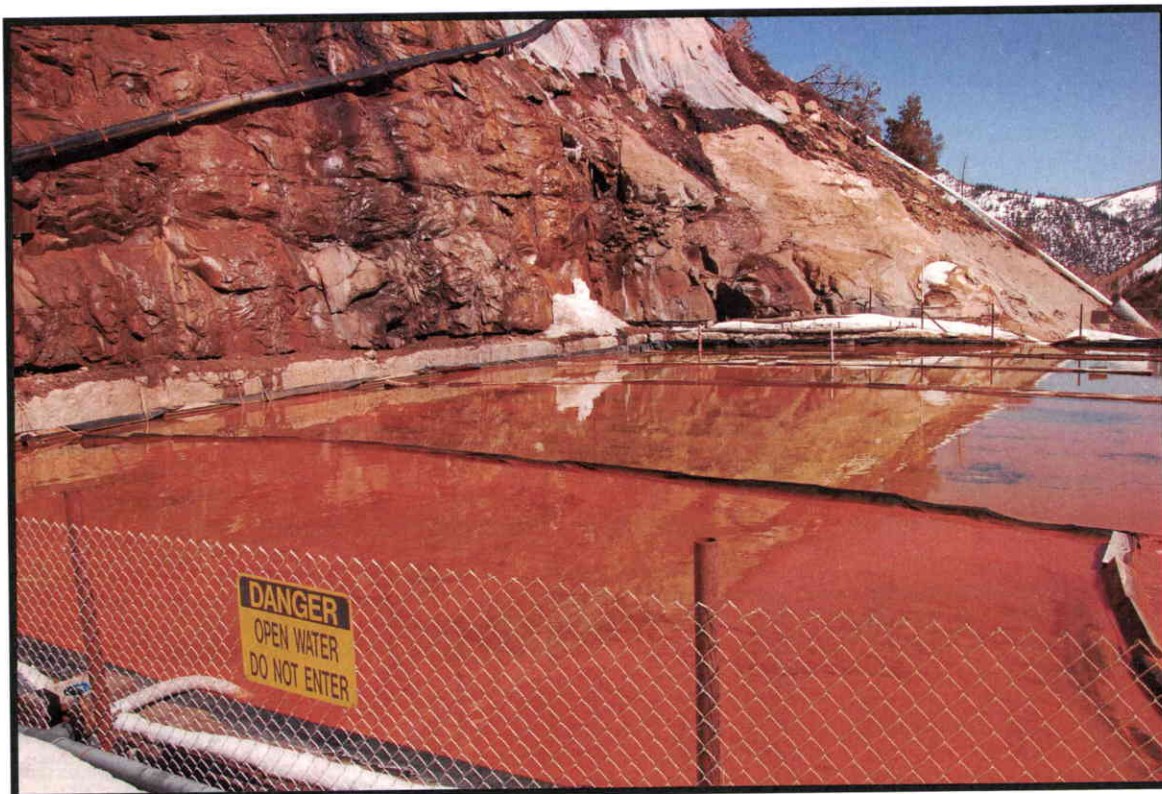
Operator is wiring a Programmable Logistics Controller (PLC) to automate alarms, flow meters, sensors, etc. Wiring is expected to be completed week of March 17. Three flow meters are to be added: freshwater to flocculant make-down unit, flocculant neat, and coagulant.

Clean water for chemical preparation is no longer being shipped to the site. Operator is using an irrigation pump to fill water tanks from treatment pond outlet. Tanks require filling every 3 days.

Flocculant dosage rate reported as 2.5 ppm (approx). Rate calculated by Operator based on 0.5% flocculant concentration in make down unit, being pumped by a 1 gpm - 60 hz pump operated at 30 hz (for 0.5 gpm). Coagulant dosage rate still approx. 38 ppm based on change in level in tote over time.

Scamp contractors were on-site cleaning the treatment pond. Per Scamp personnel, pond cleanout has been ongoing for at least 2 weeks Mon - Fri. Typically, 2 X large vac trucks and 3 X small vac trucks are filled and transported to Wildcat Loadout each day.

Mine-Water Treatment System- Looking East.

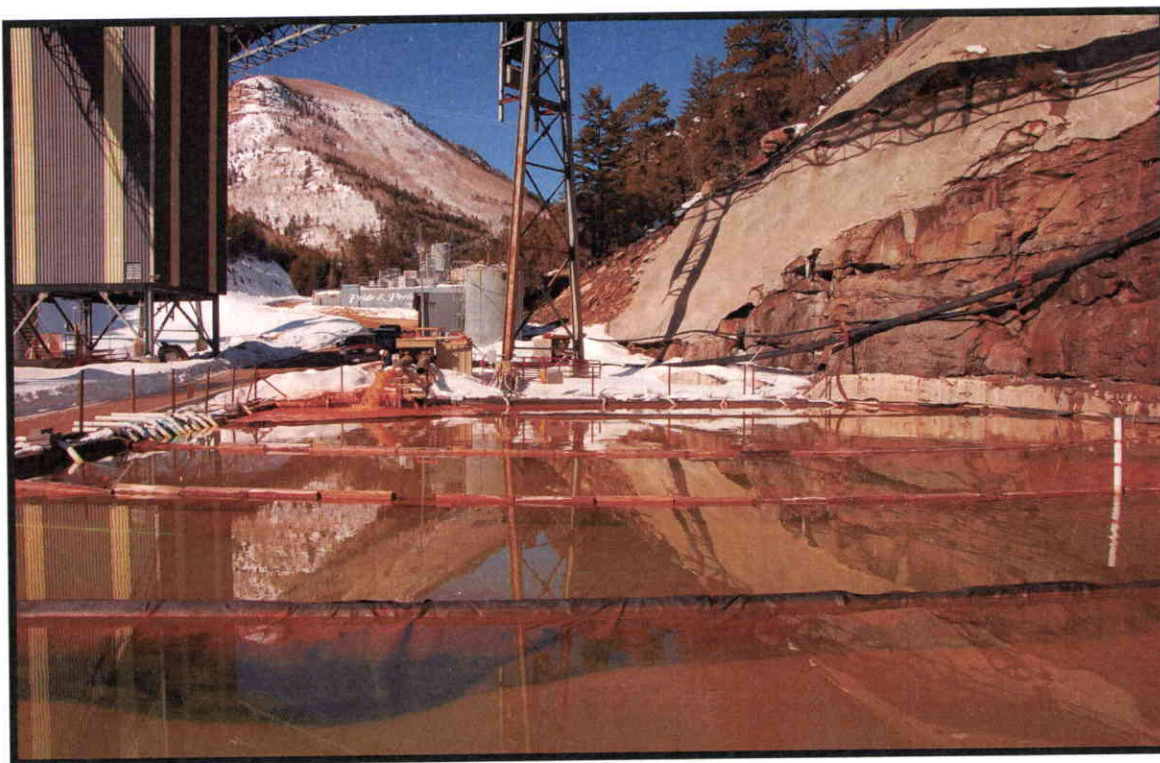
Mine-Water Treatment System- Looking West.

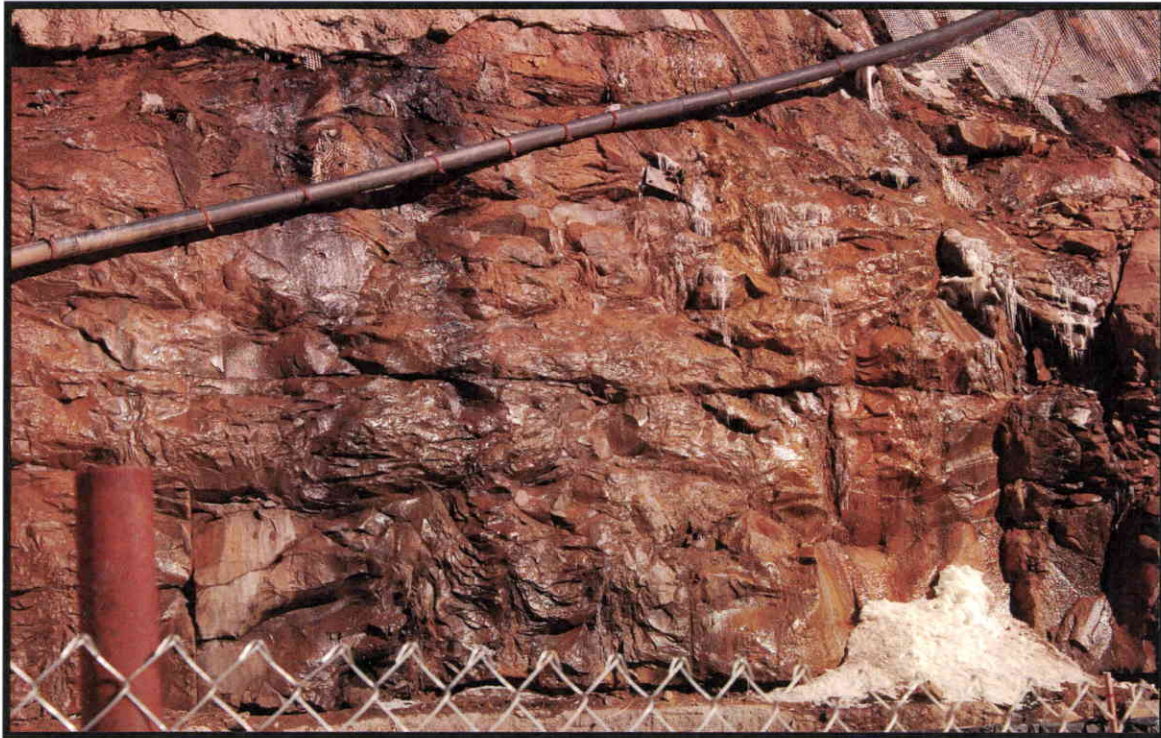
Highwall Area- Directly Adjacent to North Side of Mine

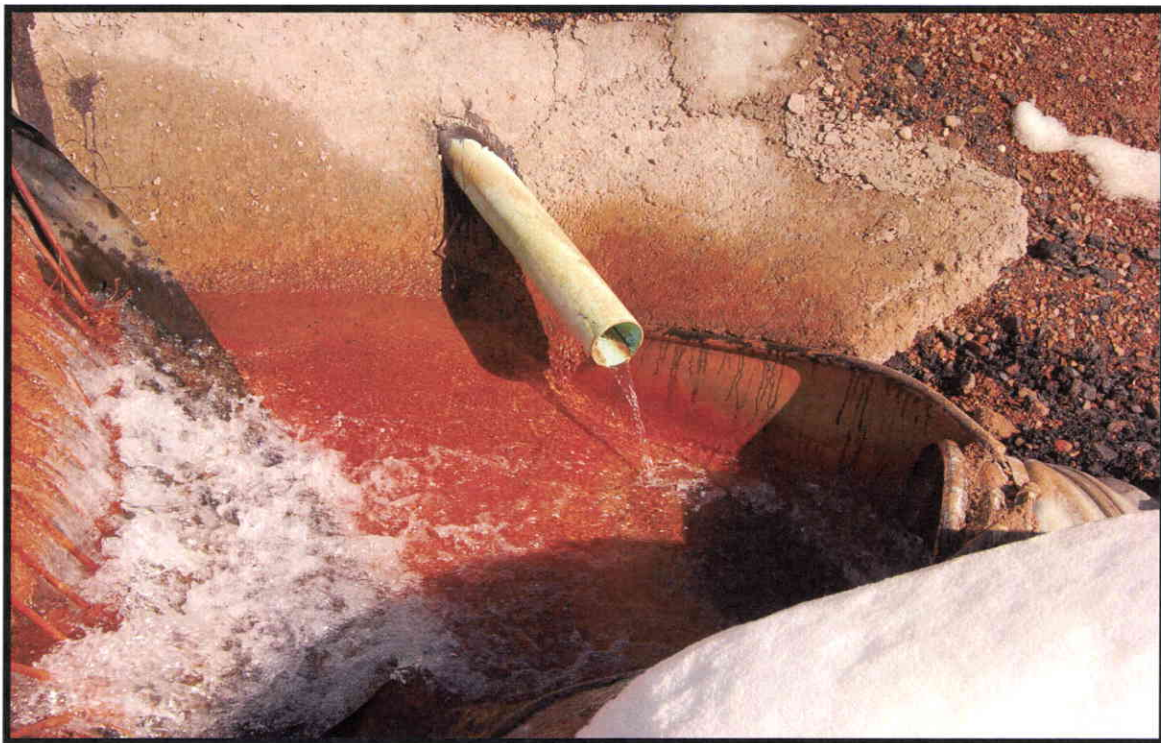
Division personnel collected samples at Pre-002 and 002 outfall. Sample Pre-002 to be analyzed for sulfate and total iron. Sample at outfall 002 to be analyzed for total aluminum and total iron.

Mine Water Treatment System Outfall and Highwall Seep Discharge

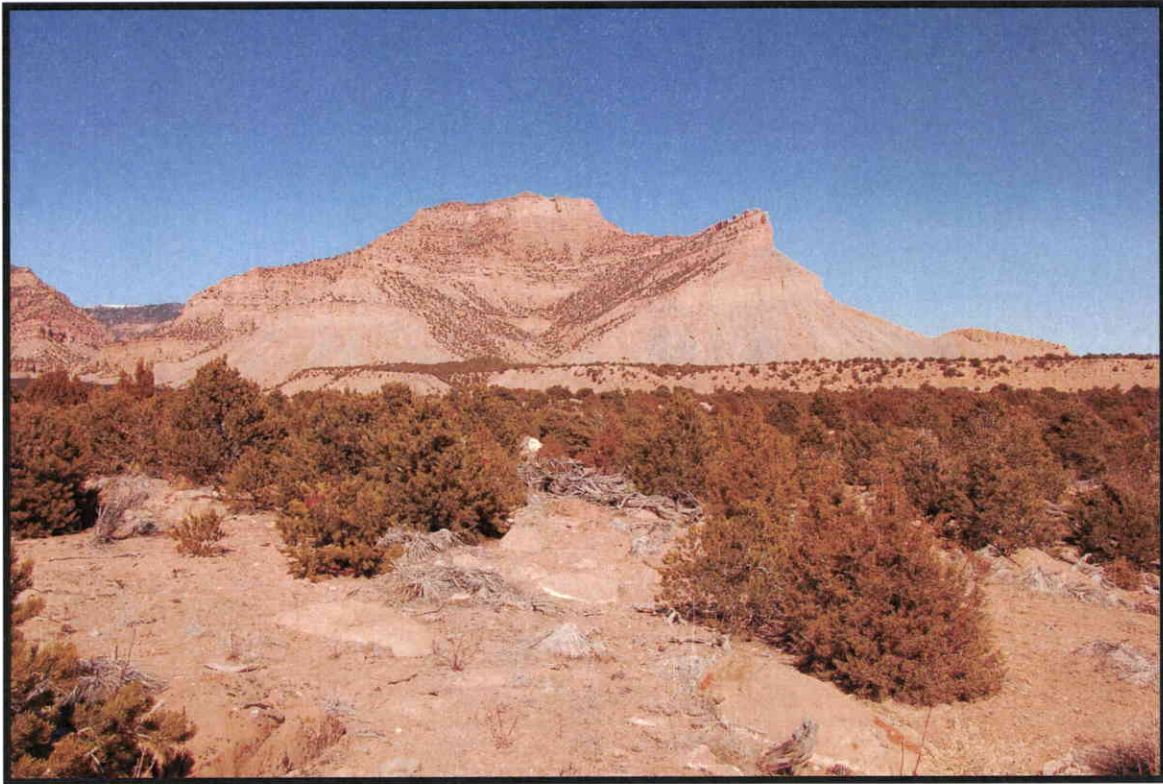
Following the inspection at the Crandall Canyon mine, Daver Shaver (Genwal Resources) took Mr. Christensen and Mr. Lundmark to a prospective iron sludge disposal site. The site is located approximately 1/4 mile north of Highway 31 across from the Huntington Canyon power plant. The company will propose the construction of at least two shallow evaporation ponds for the purpose of storing and ultimately burying the material on-site. The company is in the process of collecting the requisite baseline data (soils, archaeology, vegetation etc.) for permitting the site under the existing Crandall Canyon Mining and Reclamation Plan (MRP). Based upon the work to date, the company is anticipating the submitting the amendment to the Division within the next month or two. Based on the preliminary work thus far, Mr. Shaver indicated that it would be approximately 4-6 months before the evaporation ponds were permitted, constructed and operational.

The site is approximately 10-12 acres. Upon inspection of the site, several other industrial land-uses were observed in the areas adjacent to the proposed site. A natural gas pumping station and waste-rock site were noted during the field inspection. Mr. Shaver indicated that the site has been previously disturbed by "chaining".

Proposed Iron Sludge Disposal Area – Looking North

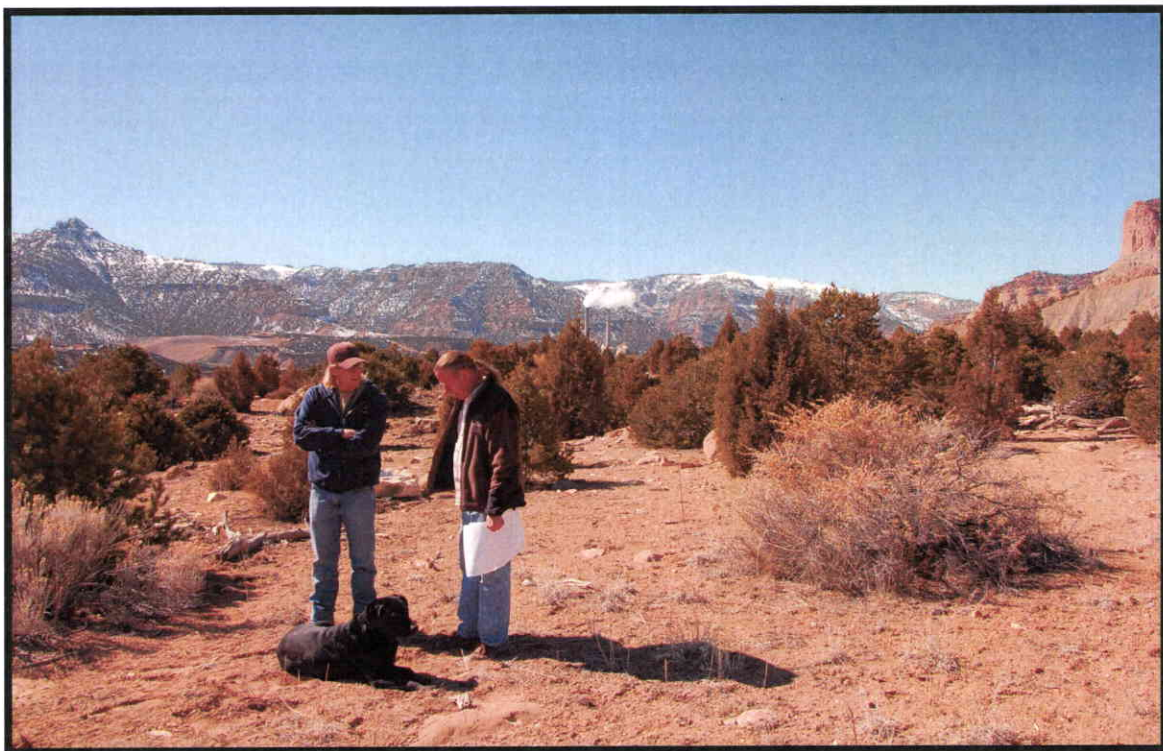
Proposed Iron Sludge Disposal Area – Looking South East
